DOT HS 809 162

September 2000

# **S-Cam Brake Effectiveness Comparison Using Two Fixtures and Two Lining Types on a Single Inertia Dynamometer**

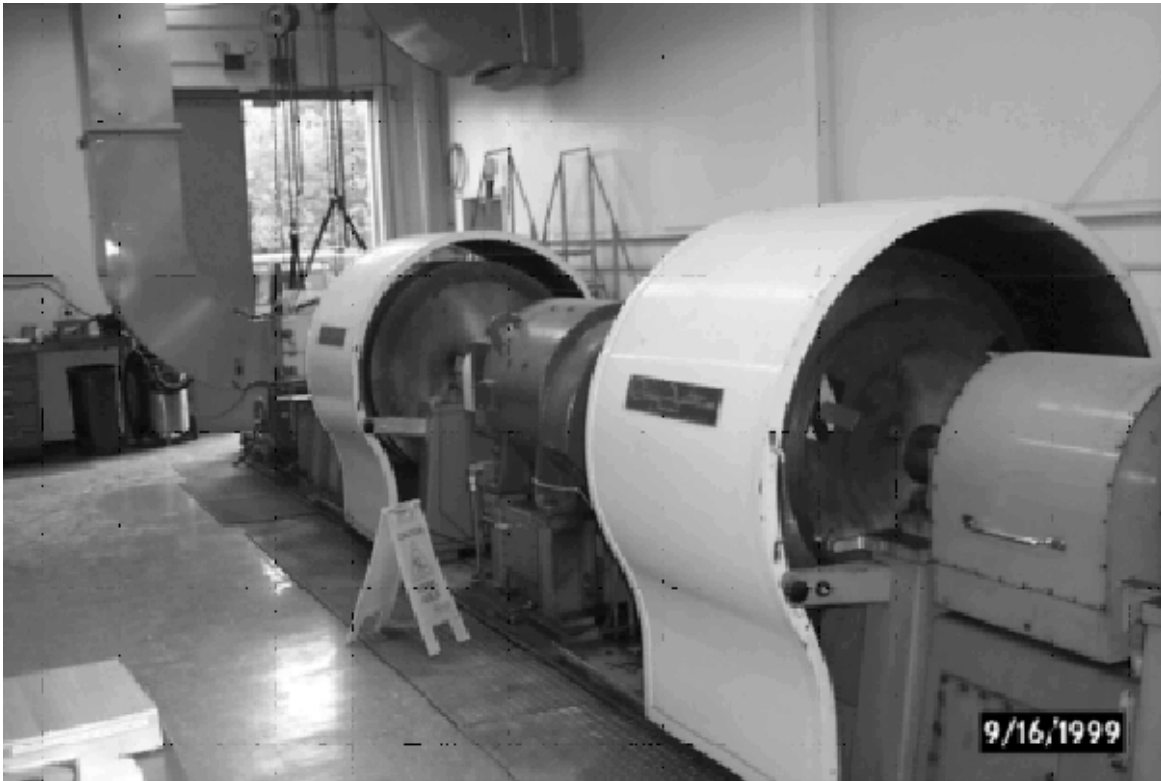
previous two round-robin test sequences. The system was equipped with several tools to perform daily calibrations on currently used channels. The entire brake dynamometer is fully calibrated on an annual basis to ensure system integrity.

**FIGURE 4.1 – Greening Inertia Brake Dynamometer**

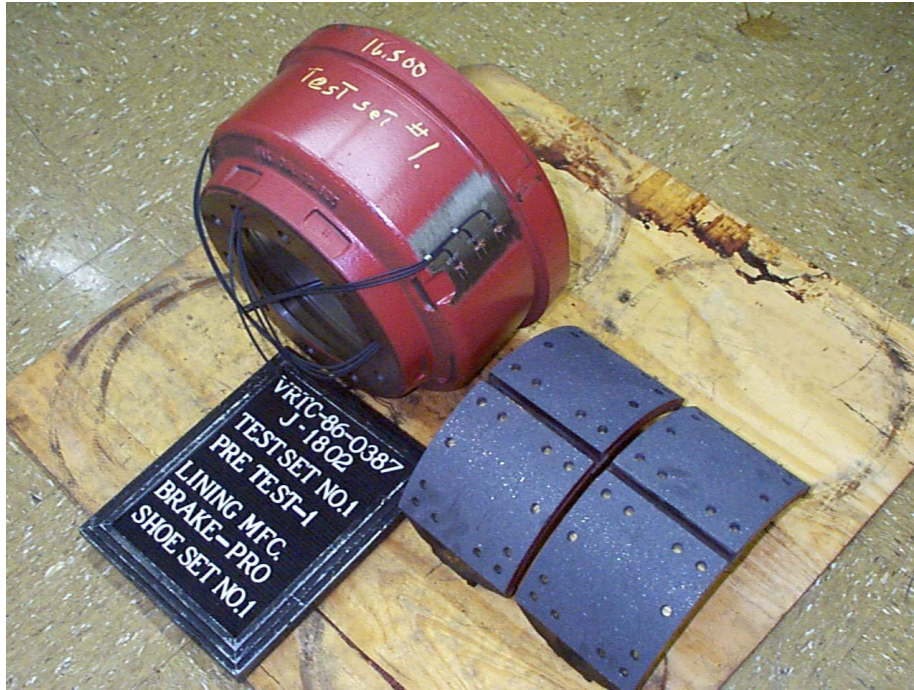
In preparation for cutting to SAE radius, all twelve wheel sets of blocks were bolted with a torque of 90-95 inch-pounds (a nominal 80 to 100 inch-pound range is specified in [Appendix B](#) of the “SAE J1802 “ standard) onto standard cast Rockwell Reference Shoes as described in SAE J1802-1 “Test Component Specifications,” [9]. A photograph of a typical shoe assembly is shown in Figure 4.2. Each assembly was visually inspected before banding on a pallet for shipment to be cut to radius.

**FIGURE 4.2 – Drum and Shoe Assemblies**
